## Experiments with Preventative Maintenance on Low Volume Surfaced Roads.

South African National Roads Agency SOC Ltd (SANRAL): Southern Region

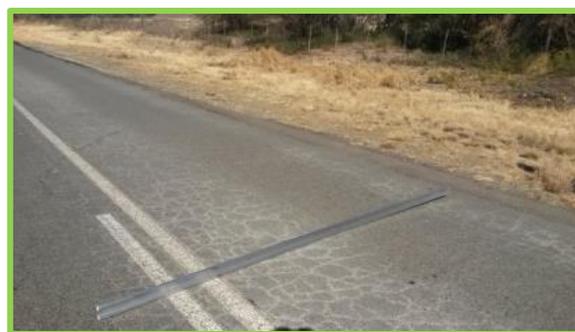
In general, 6.7mm and 9.5mm section appeared to be very dry and brittle, with degree 2 and 3 crocodile cracks accompanied by light pumping in certain areas. The extent of crocodile cracking was severe and was a matter of concern. The surface texture was very coarse as a result of aggregate loss. Figure 3-1 and 3-2 shows typical surface distress noted.

**Figure III-1: large extent of crocodile cracks**

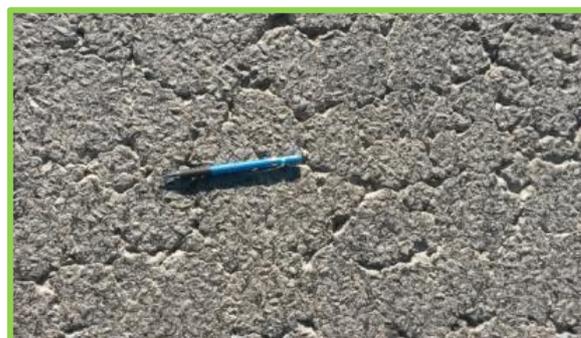
**Figure III-2: Degree 2 and 3 crocodile cracks**

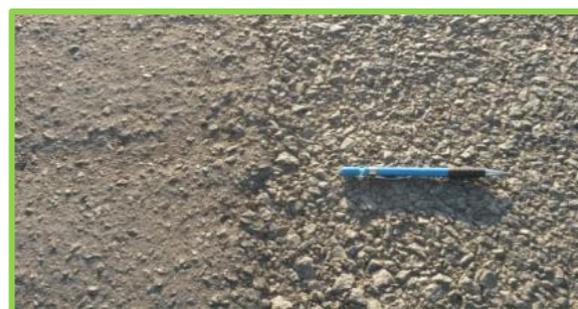
Section with 13.2mm/6.7mm seal also exhibited dryness and brittleness, with extensive rough surface due to severe aggregate loss and longitudinal cracking along the centreline with localised transverse cracking as shown on figure 3-3 and 3-4.

**Figure III-3: Slurry repairs aggregate loss**

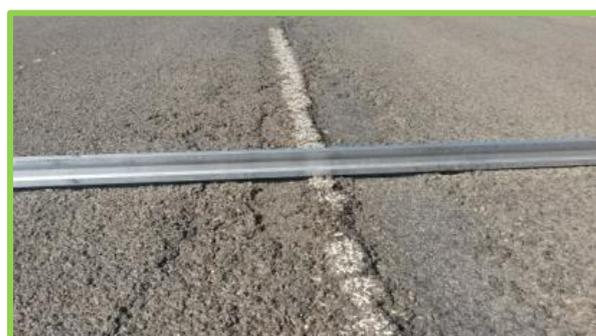
**Figure III-4: Longitudinal Cracking**

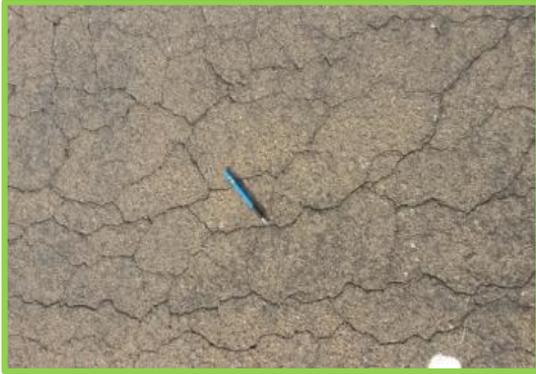
The 19mm cape seal section appeared to be also very dry and brittle with severe crocodile cracking of degree 4 to 5 with relatively smooth texture as shown on Figure 3-5 and 3-6 respectively.

Figure III-5: Degree 4 Crocodile cracks on the Cape Seal

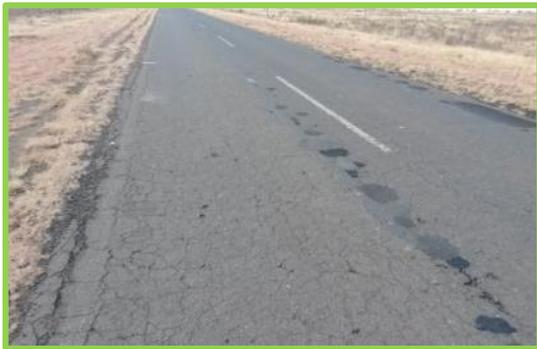
Figure III-6: Large extent of the cracked section

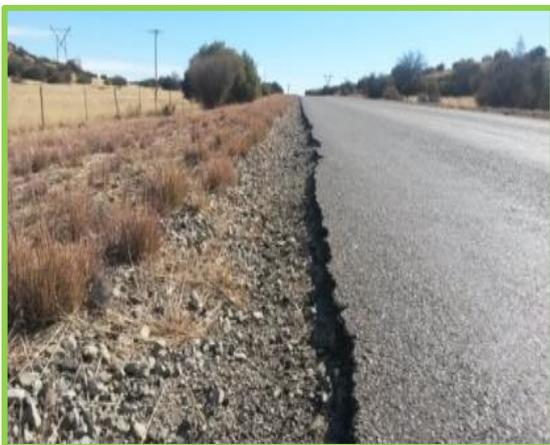
Section with narrow road width of 6.2m had major structural distress. Major rutting and shoving of asphalt surfacing was observed on localised sections, severe edge breaks and drop off with revelling shoulders. Figure 3-7 to 3-9 shows the types of structural defects noted during visual assessment.

Figure III-7: Typical Edge drop off

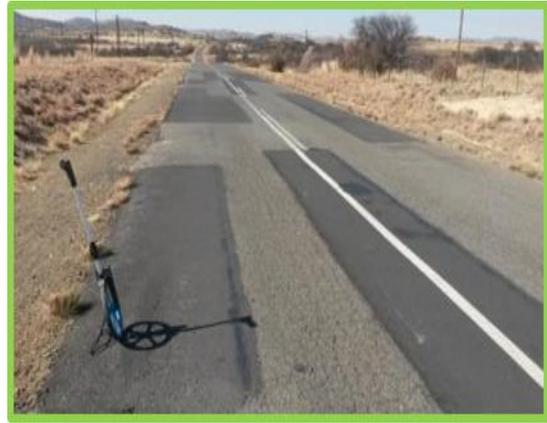
Figure III-8: High frequency of patches

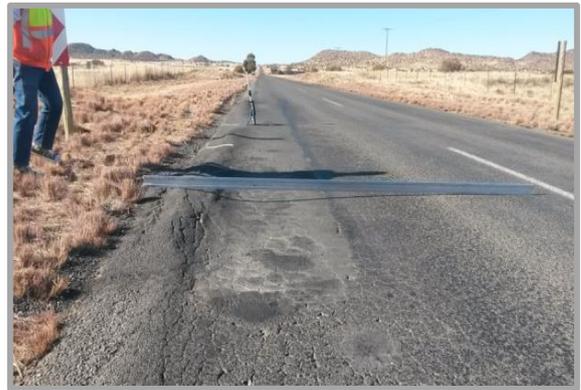
Figure III-9: Severe rutting and shoving (localised)

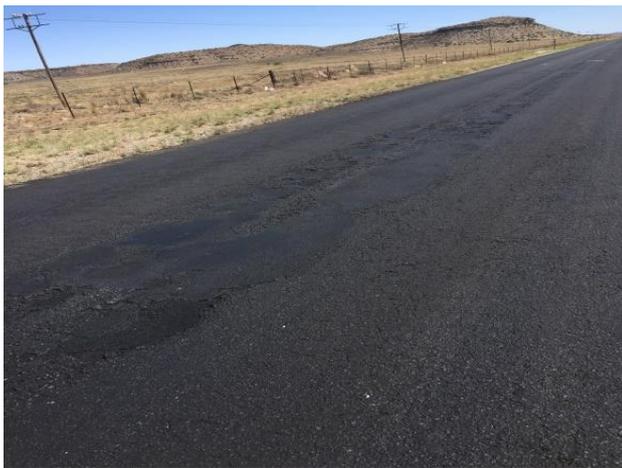
Sections that were rejuvenated using diluted anionic stable grade emulsion of 50% diluted SS60 seems to behave well without any form of binder flushing or bleeding. However challenges were experienced during constructions especially on steep gradient and sharp curves due to low viscosity of the dilution which intend to runoff. Figure 3-11 and Figure 3-12 shows the two types of rejuvenation applied.

Figure III-11: Diluted SS60 Rejuvenator

### (b) 30% spray grade anionic emulsion fog spray

Much easier product to work with as it breaks very quickly and can open to traffic within 2 to 6 hours, depending on the ambient temperature. A big disadvantage is that the product is very low viscosity and runs across the road into trafficked lanes, especially at super elevation when spraying in half widths. This can be mitigated by having labour on hand to brush “runs” with hand brooms.

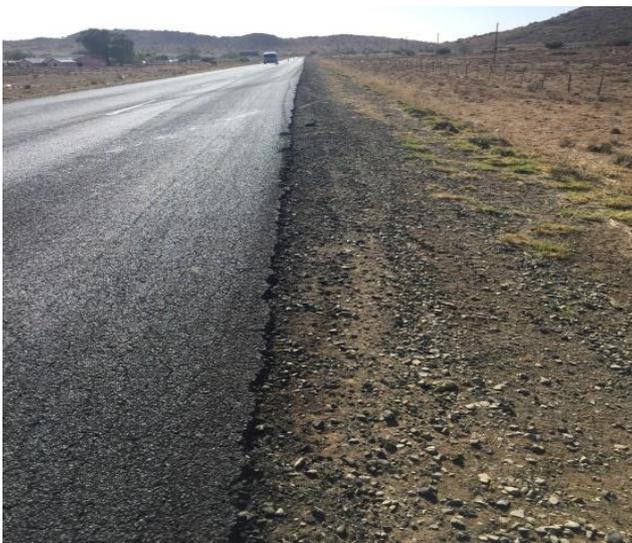
the remainder of the road section. The extent of the road was surfaced using cutback bitumen (MC3000) as a tack coat for grit seal. High degree of bleeding is being experienced on some sections of the road which is binder rich. Bleeding and flushing on geotextile patches is excessive due to high binder content and a use of cutback binder as tack coat for grit seal as our surface dressing.

Figure III-12: MSP3 Cutback Binder Rejuvenator

### (a) Rejuvenator (MSP3)

Cutback binder is a tricky product to work with, but the end result is better than a fog spray. It is very time consuming – taking a lot more time to break than a fog spray. With an application rate of  $0.5\ell/m^2$ , it takes 36 to 48 hours to break, which means you need to have day/night closures in place. From our experience on this project, when you increase the application rate to  $0.6\ell/m^2$ , it could take 48 to 60 hours to break. Even after it broke, you still need to monitor it because the product stays tacky for a while, especially when it is very hot.

In summary, the MSP3 is the better product as it brings more life into the existing seal. However, caution must be taken on the selection of tack coat to be used for final surfacing as to mitigate high degree of bleeding and bitumen flushing.

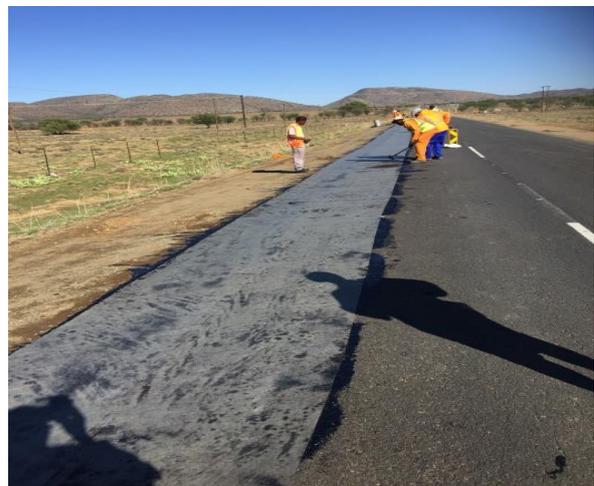
Alternative pre-treatment measures trialed on various section of the road as discussed included geotextile patches and extensive rut filling as well as some conventional repair methods such as base patches and surface patches for section with severe pavement distress with associated cracking of degree 4 to 5 respectively.

Figure III-13: Typical Geotextile Patch

Sections indicating base failures need to be assessed carefully in deciding when to push the limits and opt for non-conventional ways as at times the non-conventional measure acts as a bridging layer. Due to bleeding observed, application rate of binder to the geotextile patches should be reduced significantly as well as application rate of tack coat for sand

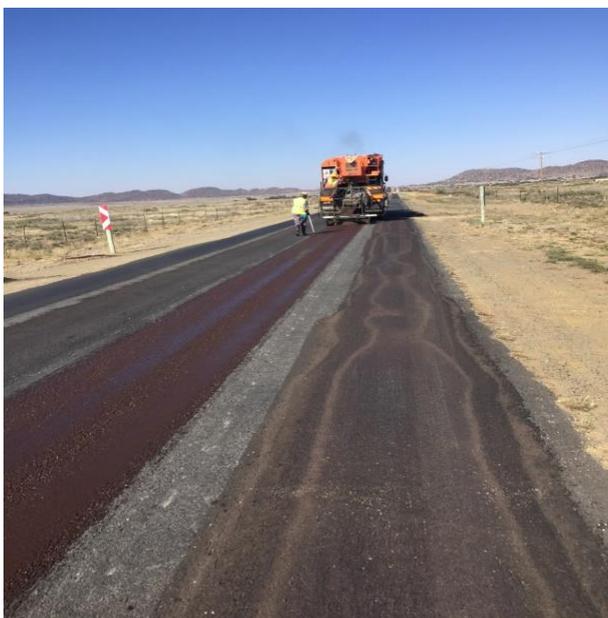
**Figure III-14: Rut fill slurry using Microsurfacing machine**

Slurry rut fill repairs (rapid setting slurry) were applied on distressed areas where rutting of 15 to 25mm deep occurred in combination with crocodile cracks of degree 2 or less. It has become apparent that the cracks are reflecting through the rut fill slurry as well as the new seal. As a levelling layer/holding action this could be deemed to be acceptable, however, if a longer-term repair is required the better alternative would be to repair ruts (in combination with cracks) by means of asphalt surface inlays. The slurry rut fill repairs appear to be most effective in areas where no associated cracking exists.

**Rapid Setting Slurry or Microsurfacing:** Such low traffic roads with deformations and extensive rutting, patching had to be reduced to absolute minimum. It remains vital to make rational decision when considering using certain alternative repair options as supposed to conventional methods such as base patching to repair ruts. Microsurfacing includes *Ralumac rut fill slurry*, which was extensively used on R58 project to address the exhibited ruts. However, it is important to understand the design and the properties of the rapid setting slurry to ensure compatibility between aggregates to be used and the type emulsion. Rapid setting slurry mostly uses cationic emulsion with additive that enhance the setting time. The designs for Rapid Setting slurries and Microsurfacing is highly specialised and selection of additives can be complex, so it is recommended that the design of Rapid Setting Slurries and Microsurfacing to be left to the supplier of the product. It is also advisable to understand the effect of the additives on the setting time, a balance should be obtained ensure no early breaking during construction, but sufficient additive to open for traffic as early as possible (3).
