SURFACING OPTIONS FOR LOW VOLUME ROADS IN MOZAMBIQUE

Abstract

Keywords— gravel, penetration macadam, Otta seal and sand seal (armoured base)

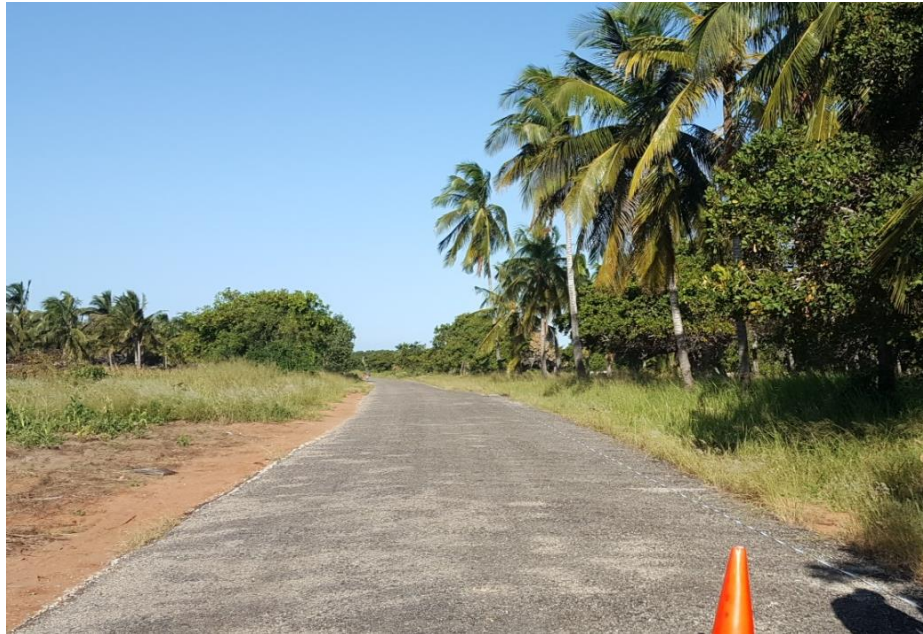
Fig. 5 Penetration macadam section

The pavement structure of the penetration macadam section comprises three layers: road bed, sub base and base.

The sub base consists of a local red sand, with 150 mm, compacted to a minimum of 93% Mod. AASHTO Maximum Dry Density (MDD).

The base of the road section is untreated red sand, the same material as the sub base, with 150 mm, compacted to a minimum of 95% Mod. AASHTO MDD.

The surfacing is composed of two layers, the bottom one with crushed calcrete aggregate between 20 – 40 mm, and the top one with 10 – 13 mm calcrete aggregate. The binder used was SS60 emulsion with an application rate of 1.2 lt/m².

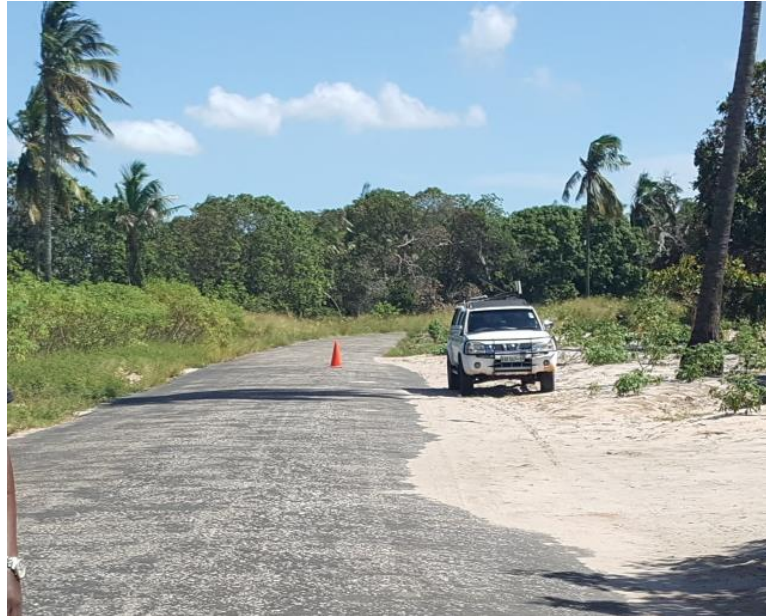
Fig. 7 Sand seal on armoured base section

The base of the road section is the same red sand as the subbase, 100mm layer, compacted to a minimum of 95% Mod. AASHTO MDD, and an armoured, 50 mm layer, nominal size crushed calcrete aggregate.

The single sand seal surfacing used a coarse sand passing 4.75mm, and an SS60 bitumen emulsion binder with an application rate of 1.2 l/m².

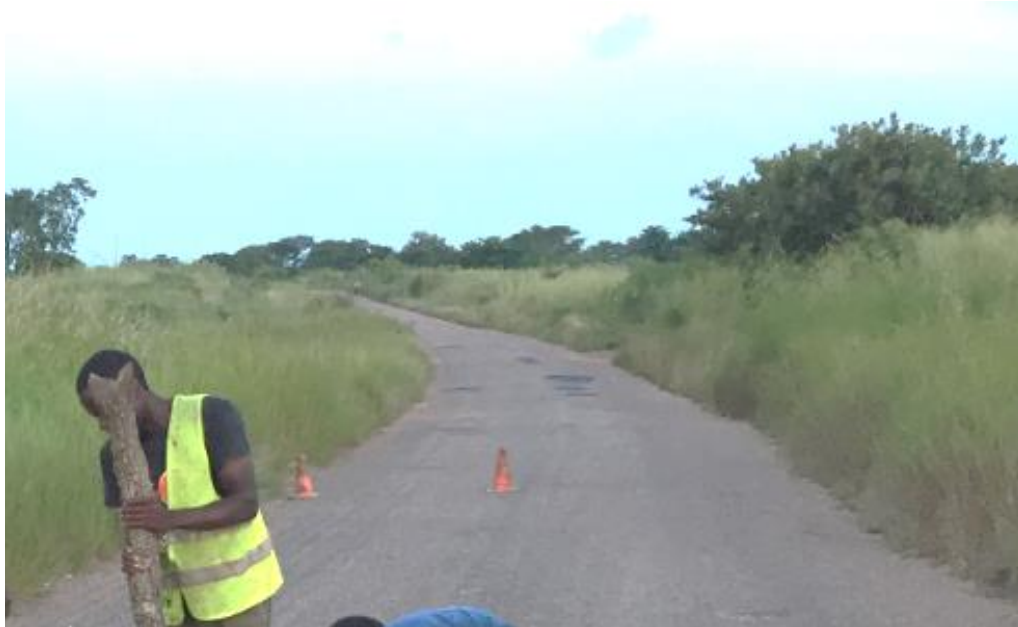
Fig. 9 Otta seal section

The base of the road section is the same material as sub base compacted to a minimum of 95% Mod. AASHTO MDD, in 150 mm layer.

The Otta seal used aggregate with a maximum size of 13mm, and had a binder application rate of 1.2 – 2.0 l/m²- MC 3000.

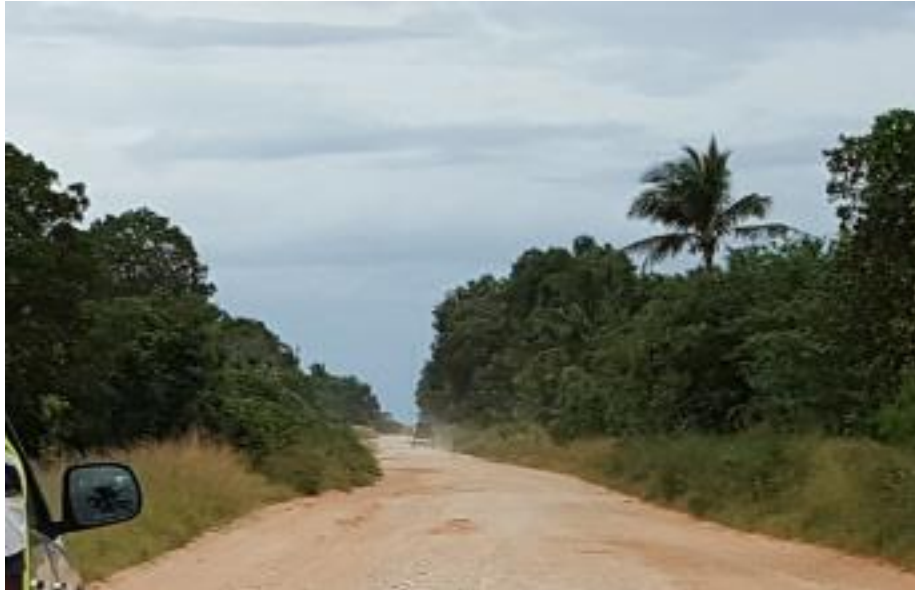
Fig. 11 Gravel Section

The Gravel section is composed of three layers: road bed, base and wearing course.

The sub base is local red sand, compacted to a minimum of 95% Mod. AASHTO MDD in 150 mm layer.

The base of the road section is a red sand blended 1:1 with calcrete in a 150 mm layer compacted to a minimum of 95% Mod. AASHTO MDD. This layer is same as wearing course.
